A Half-Inch to Failure: Minneapolis Bridge Collapse

Leadership ViTS Meeting

September 2009

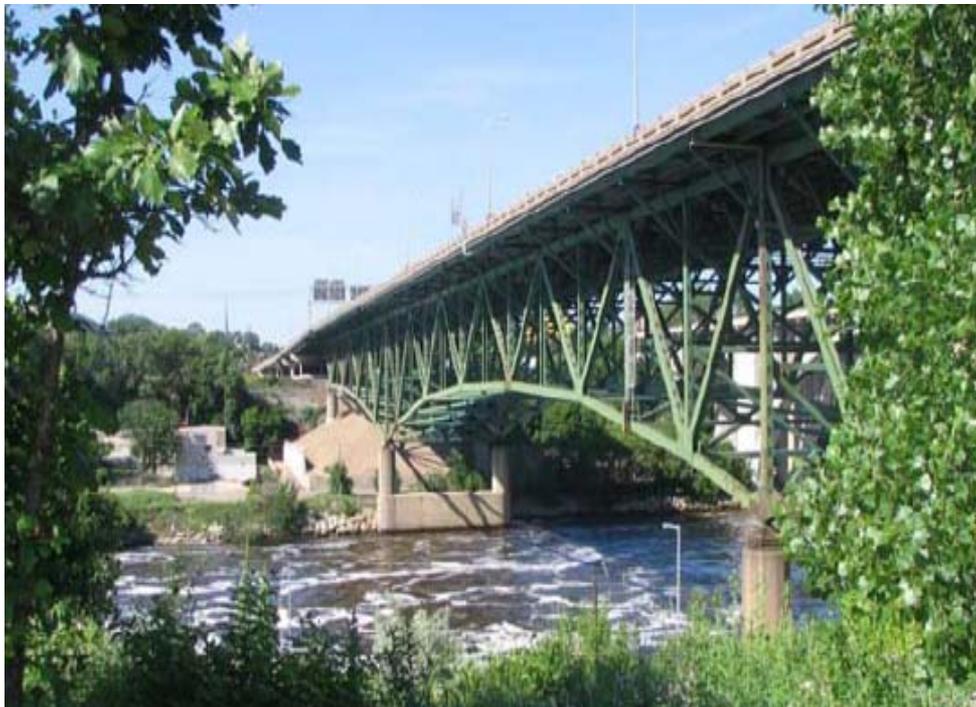
The I-35W Bridge

I-35W was a steel truss bridge consisting of straight beams formed into triangular units. The ends of the beams were connected with riveted metal plates called gusset plates. Well-designed gusset plates can support 2-3 times the expected bridge loads, and are stronger than the beams they connect. The as-designed gusset plates on I-35W, however, were only half an inch thick...half as thick as needed.

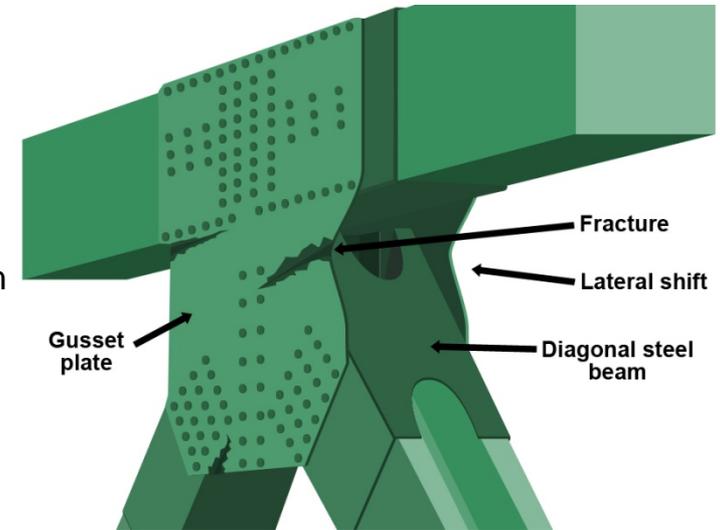
Artist's Rendering of a Fracturing Gusset Plate

Integrity of gusset plates overwhelmed by improper design and the weight of rush hour traffic, previous additions to bridge deck and a concentration of heavy construction materials and equipment.

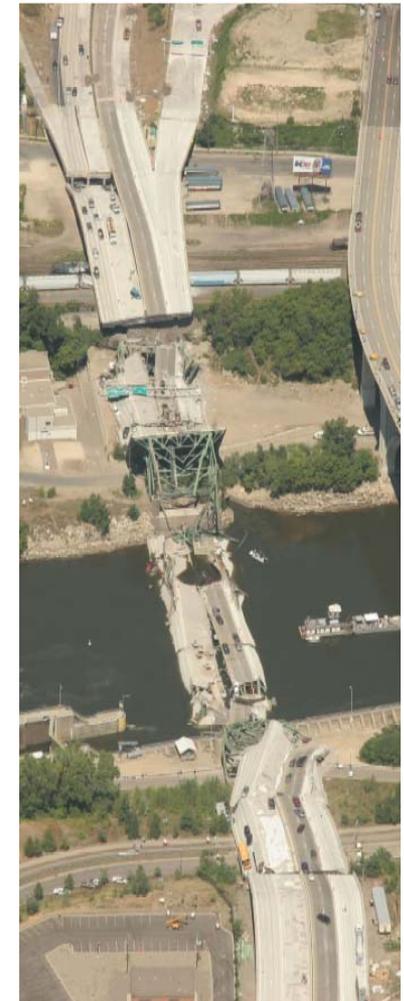
**I-35W Bridge on August 2, 2007,
the day after the collapse**
